SIMSITE® Impellers Improve Performance & Reliability with Sludge Handling Pumps

Pump Description

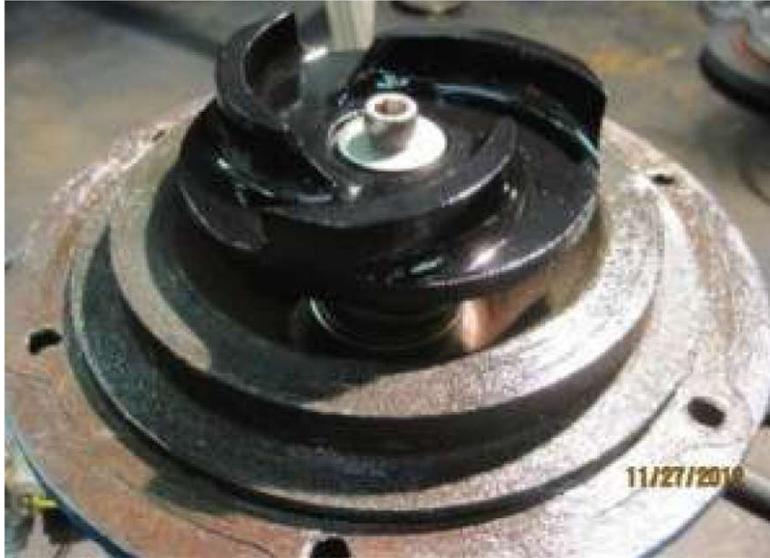
**SIMSITE® Non-Clogging Impeller
not clogged by the fibers**

The Test Stand was then drained, and upon inspection of the pump, it was found that the Non-Clogging SIMSITE® Impeller was absolutely free & clear from the fibers. This fact proves that the Non-Clogging SIMSITE® Impeller is working as it was intended, permitting the pump to handle the stringy materials without clogging or deteriorating pump performance.

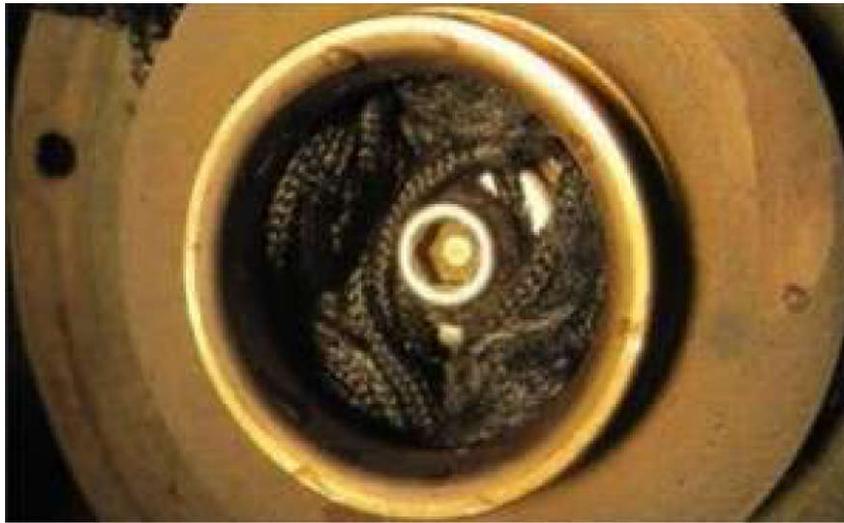
Clogging of the Enclosed Metallic Impeller

As we added more fibers the capacity continued to drop until it was down to less than 40 GPM. At this point all the fibers were in the test loop system, but the fibers were no longer circulating through the test loop. Upon stopping the test and opening the pump for inspection of the Enclosed Metallic Impeller, we found that a large majority of the fibers have become clogged inside of the enclosed metallic impeller. Most of the fibers had become intertwined with the blades of the impeller.

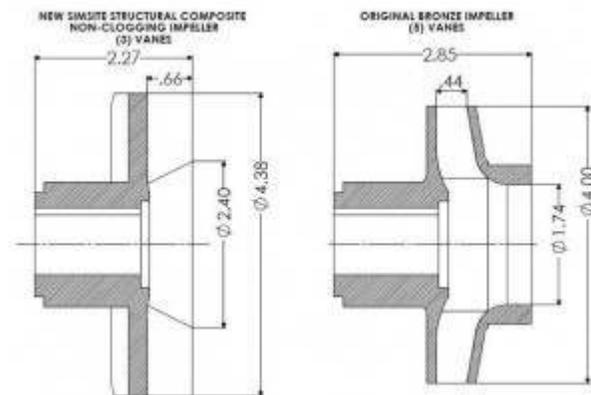
To maximize performance and efficiency, the shape of the vanes, exit port and impeller diameter had to be modified. The drawing below compares the open-faced SIMSITE® Structural Composite Non-Clog Impeller with the original Enclosed-Design metallic Impeller.

Non-Clogging SIMSITE® Impeller vs. Enclosed Metallic Impeller

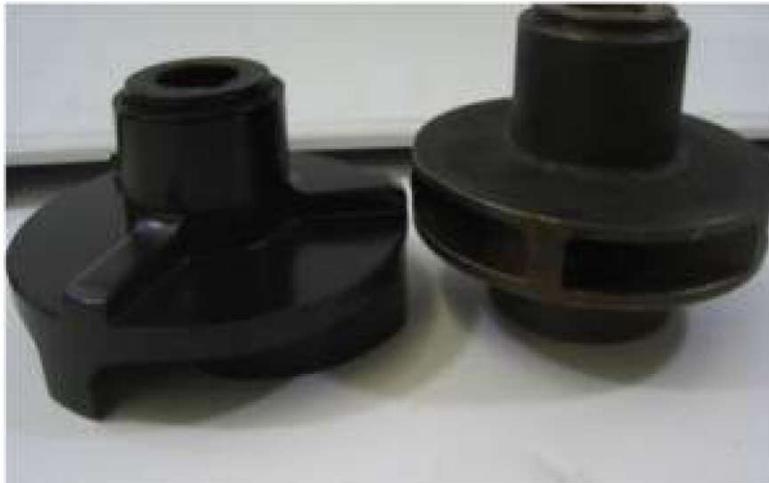
SIMSITE® Non Clogging Impeller next to Conventional Enclosed Impeller

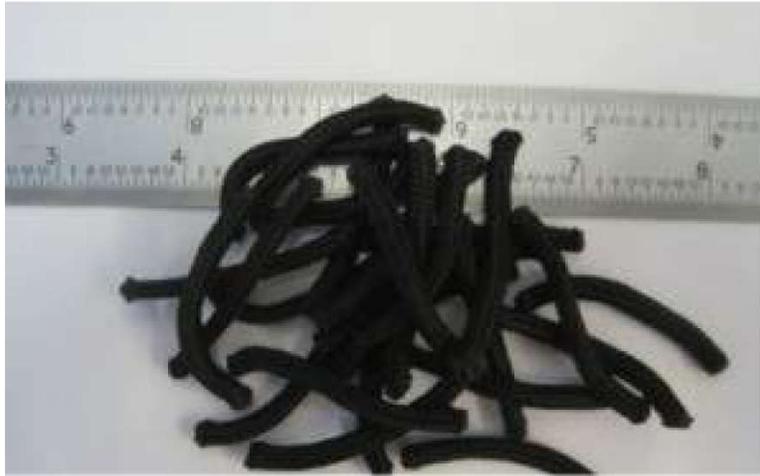
Nylon strings were chosen to simulate fibrous material. The 2 inches long by 1/8-inch diameter soft flexible nylon rope was cut for the test to simulate fibrous debris.

The pictures below show an individual fiber and a number of them together ready for the String Handling Test.

Simulation of fibrous Material

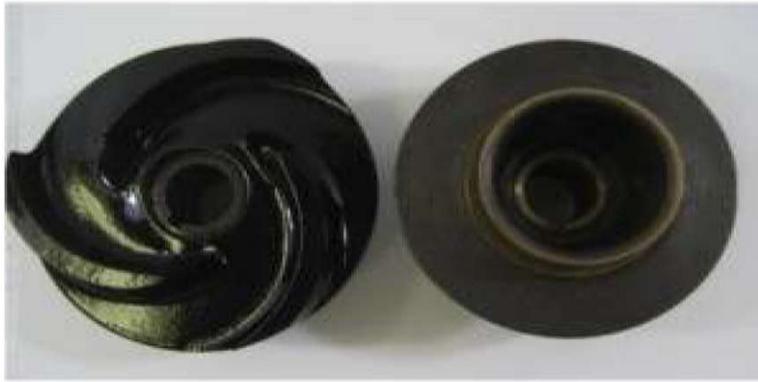
Meridional Profile of Non-Clogging SIMSITE®
Impeller vs. Conventional Enclosed-Design
Metallic Impeller

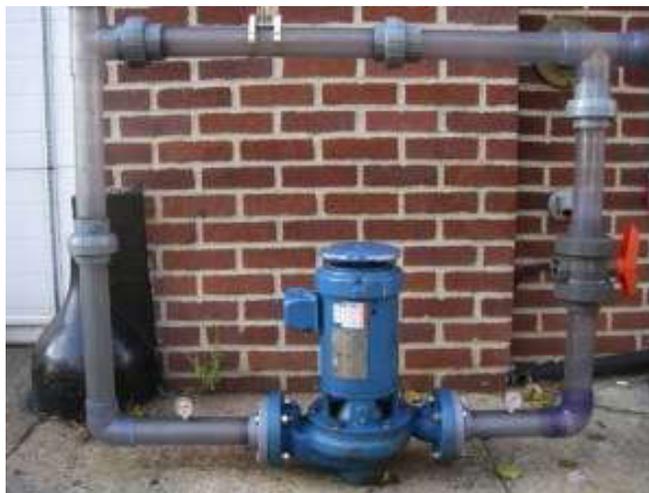
The pump was then disassembled and fit with the Non-Clogging SIMSITE® Impeller. The same String Handling Test was performed. The pump was once again set up to run at the operating design point of 80 GPM at 48 Ft of Head at 3500 RPM. The 25 strands of fibers were introduced into the pump Test Loop. The pump performance was not changed, and we observed the fibers freely circulating throughout the Test Stand. The Non-Clogging SIMSITE® Impeller handled the fibers without any deterioration of performance or efficiency! There was no drop in performance and no noticeable vibration, or noise, was detected either. Even after SIMS put in (75) seventy-five strands of the fibers into the Test Loop, the Non-Clogging SIMSITE® Impeller kept on pumping the fibers through the test loop without any noticeable drop in performance, or efficiency!!!

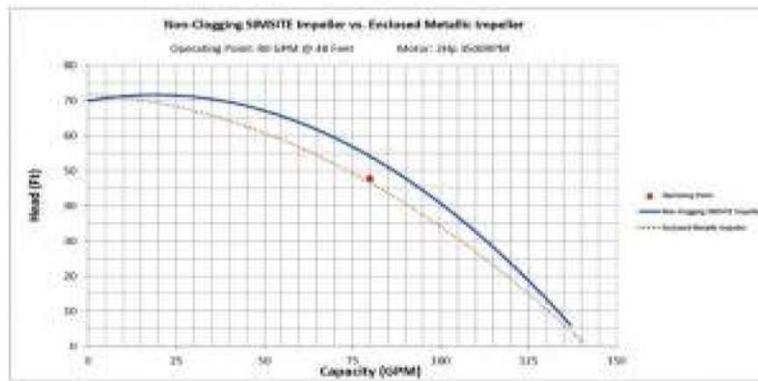
It can be clearly seen that the Non-Clogging SIMSITE® Structural Composite Impeller not only matches the original performance requirements, but even outperforms the original Enclosed Metallic Impeller. This testing was done with clean fresh water at ambient temperature. For the first test, no fibers were added into the loop to properly test the pump performance.

Comparison of Pump Performance with SIMSITE® Non-Clogging Impeller vs. Conventional Enclosed Impeller

The graph below shows the pump performance with the SIMSITE® Non-Clogging Impeller vs. the Enclosed Metallic Impeller.
